NEW CONSTRUCTION AT SYRIAN SITE

JANUARY 14, 2008

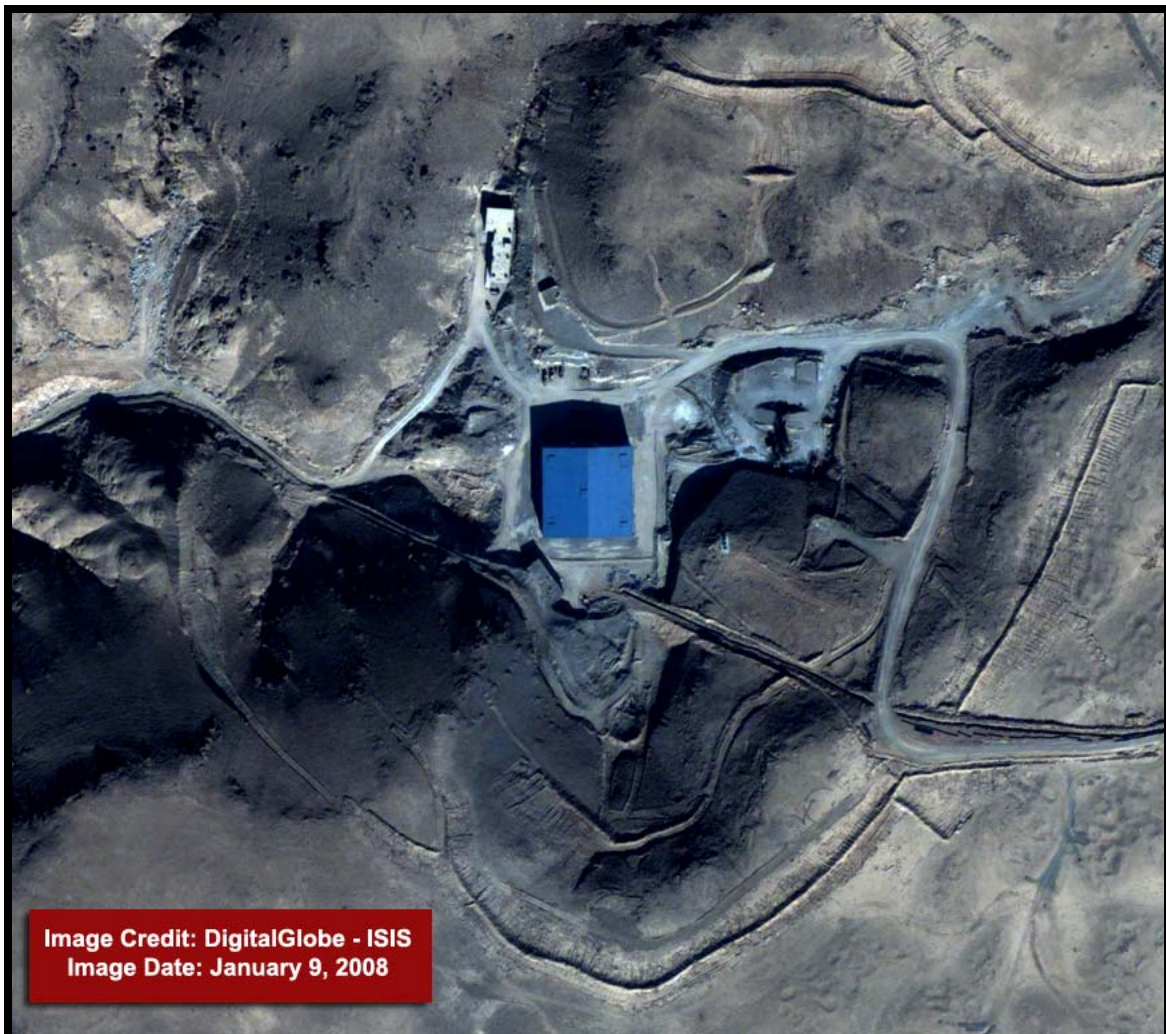
Figure 1.

Satellite imagery taken January 9, 2008 and obtained by ISIS from DigitalGlobe shows new construction at the site in Syria bombed by Israel in early September 2007 (see figures 1 and 9). ISIS identified the likely target site of the Israeli raid in an [October 24, 2007 report](#). The destroyed building was widely reported to be a nuclear reactor under construction¹.

The new building has dimensions of approximately 60 meters by 60 meters, larger than the destroyed building, which had dimensions of about 47 meters by 47 meters. In addition, the roof on the new building is vaulted at the top instead of flat. The height of the new building was not determined from the imagery.

The building's purpose can also not be discerned from the satellite imagery. There are trenches and what appear to be sections of pipe east of the building (running away from the river). The trenches and pipes can be seen in the imagery for several kilometers. The trenches end at a site that may be a water treatment facility (see figures 2 through 6).

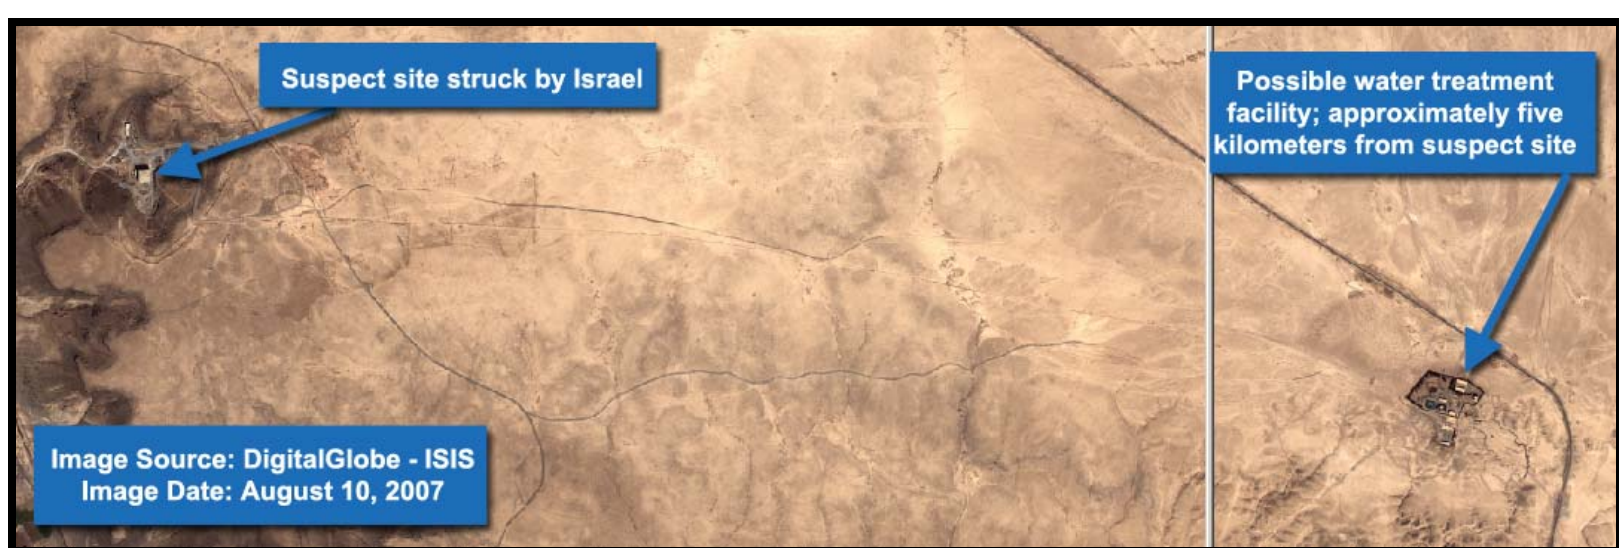
Figure 2. August 10, 2007 wide image of suspect site and possible water treatment facility.

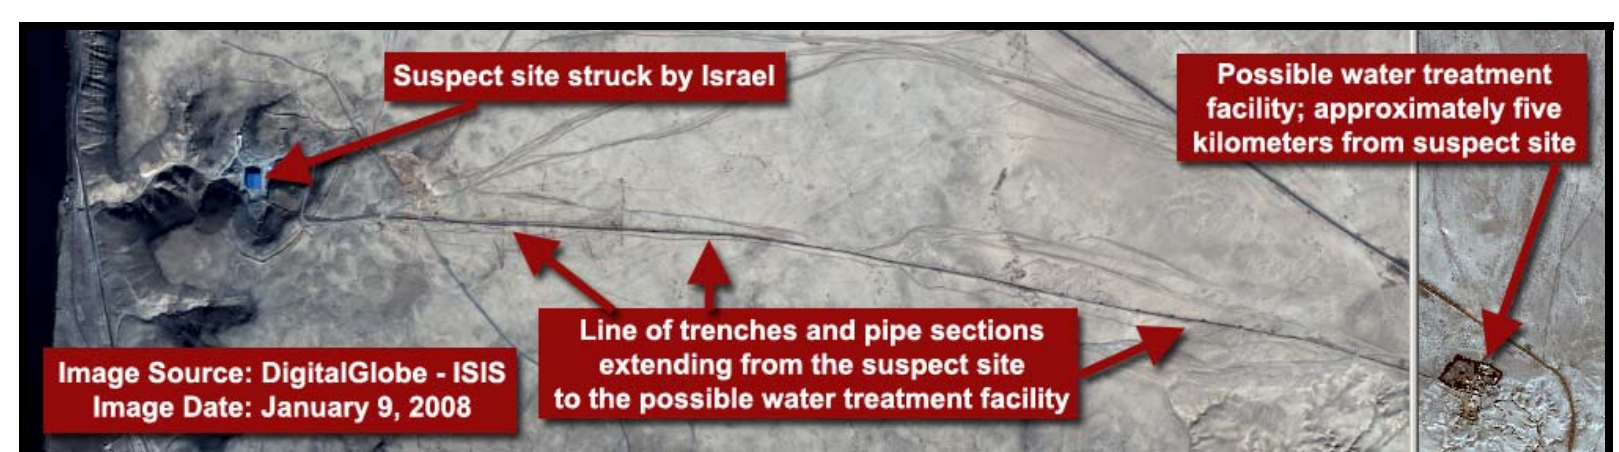
Figure 3. January 9, 2008 wide image of suspect site and possible water treatment facility.

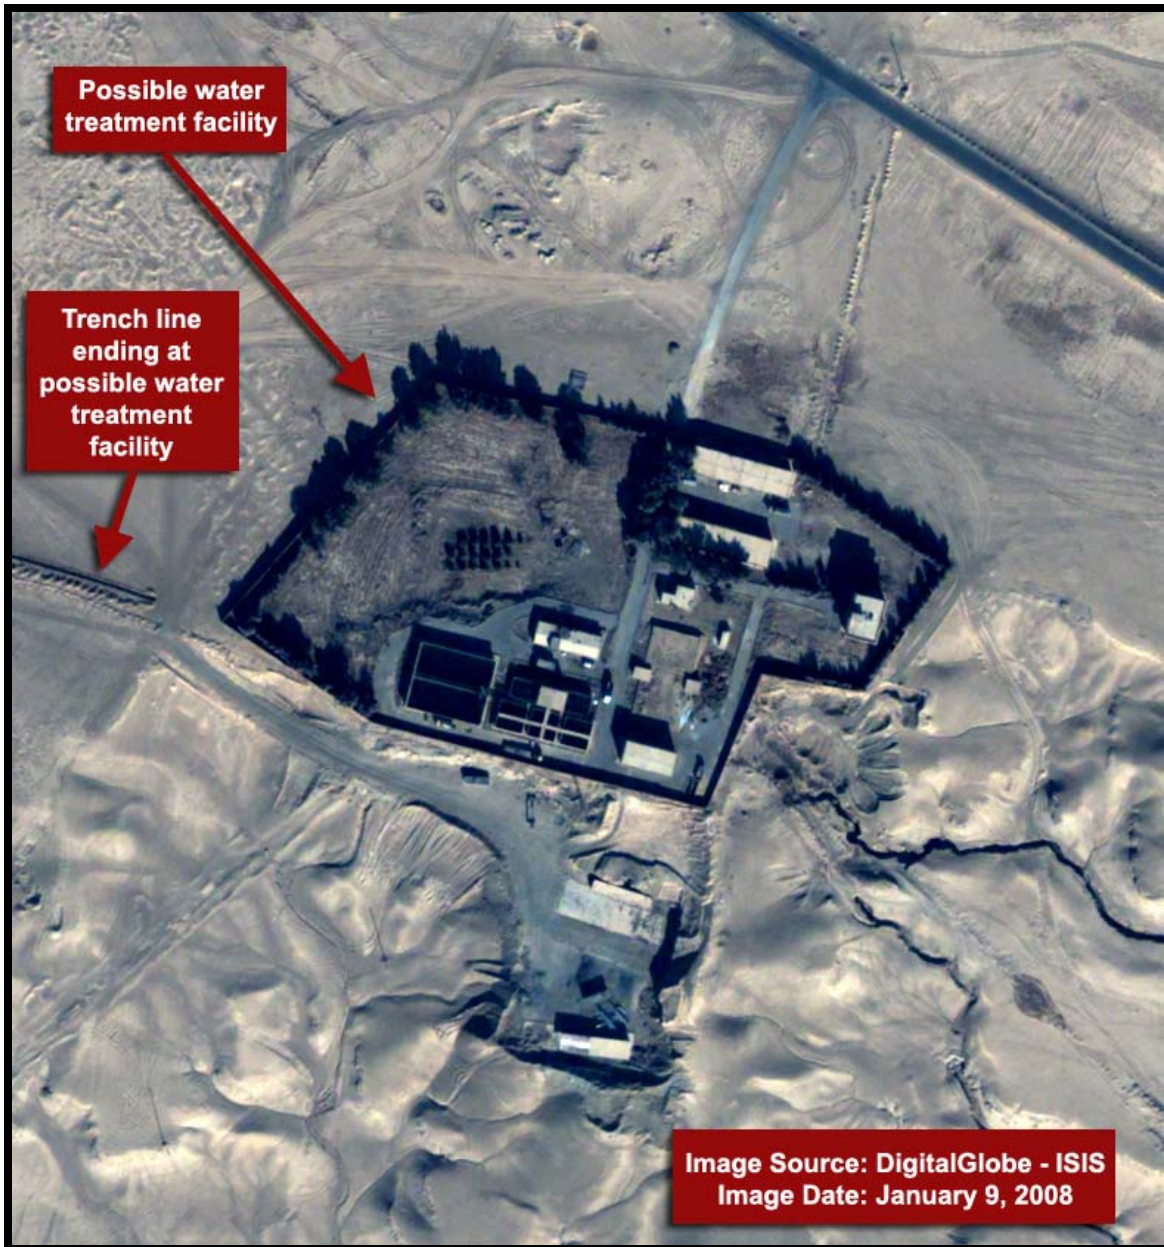
Possible water treatment facility

Trench line ending at possible water treatment facility

Figure 6. January 9, 2008 image of possible water treatment facility

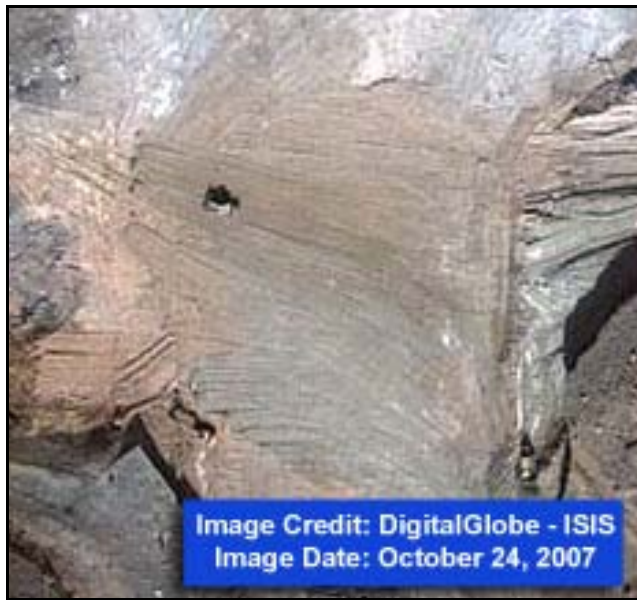
Figure 8. October 24, 2007 image showing the building removed and perhaps partially buried after the September 6 Israeli raid.

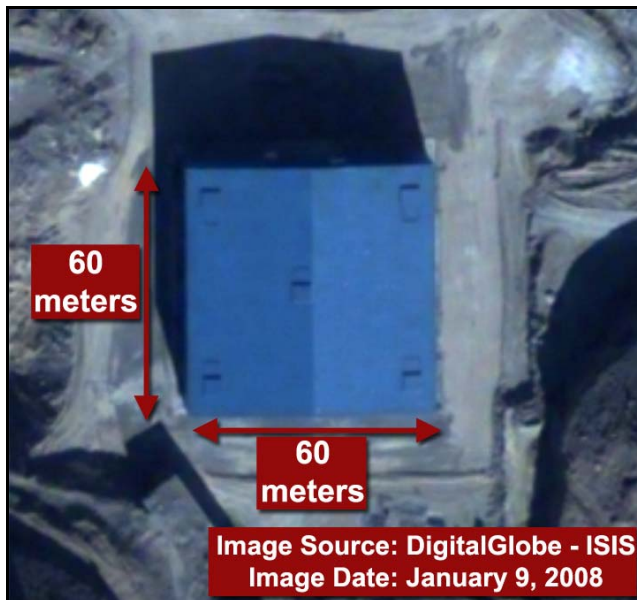
Figure 9. January 9, 2008 image of new structure at the suspect Syrian site. The new structure is approximately 13 meters wider than the original structure on each side.
